FACT SHEET #4

BLM MAKES PROGRESS IN THE CLEANUP OF THE VETA GRANDE MINE SITE

Veta Grande Mine Site Fall, 2001

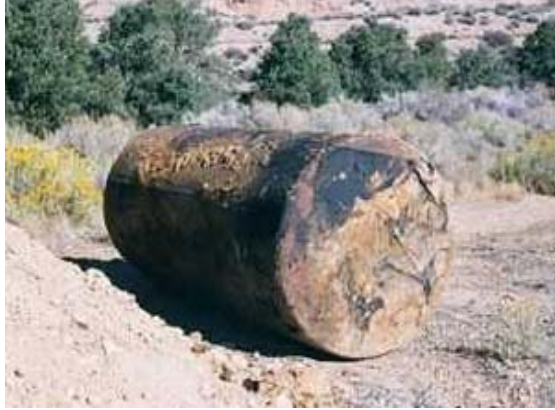
Figure 3. Underground storage tank at the Veta Grande mine site. As of 10-15-2001, this tank has been removed from the site.

- ◆ In October of 2001, BLM contracted with Philip Services to cleanup trash, junk, scrap metals, abandoned mining equipment, and to excavate and remove an empty underground storage tank (Figure 3). Over 700 cubic yards of debris were delivered to a local metal recycling firm or properly disposed of in a landfill.

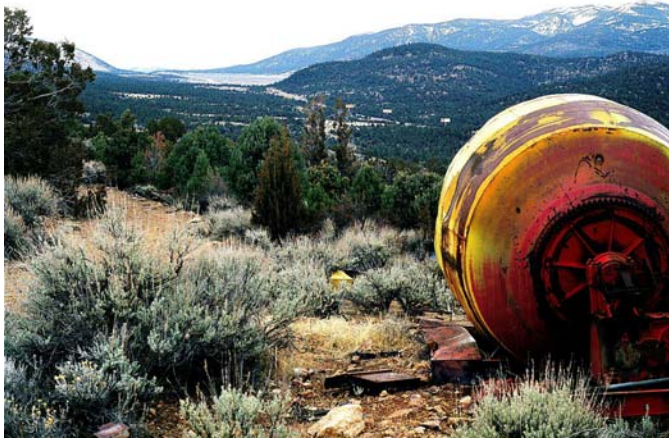
Before cleanup: Cement mixer, circa 1953

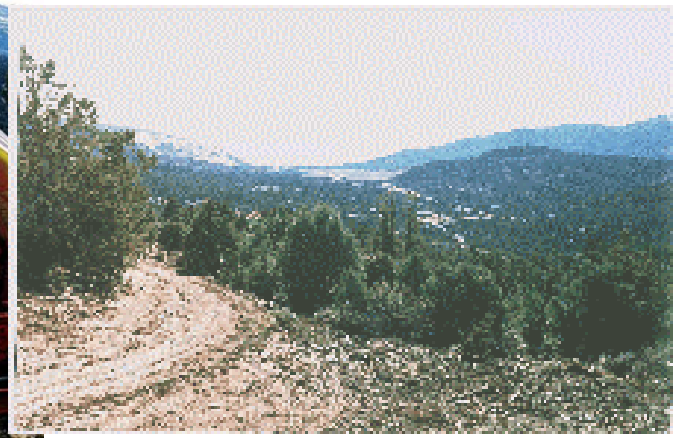
After cleanup:

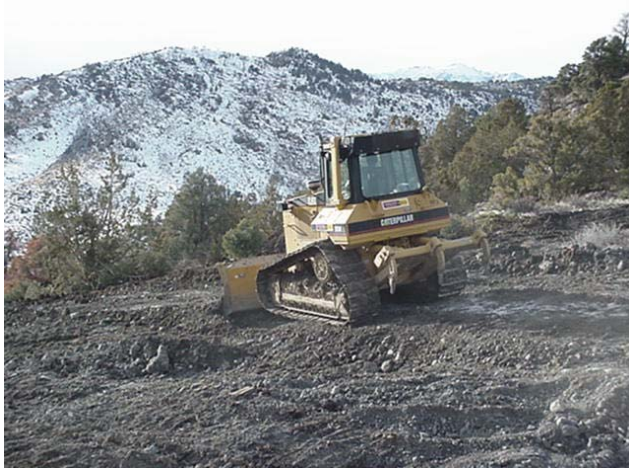
Cyanide pit cleanup in progress, scraping to bedrock.

◆ In December 2001, Environmental Quality Management Inc., of Lynnwood, WA., began earth-moving operations at the cyanide pit. Contaminated soils were removed from the cyanide pit and encased in thick, impervious plastic on-site. The cyanide pit area was excavated down to the bedrock, partially backfilled with dirt, covered with an impervious plastic liner and an additional layer of dirt that has been contoured and seeded with native species.

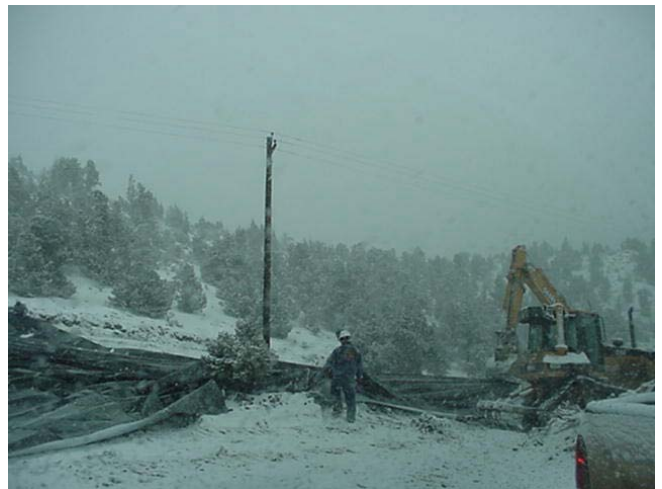
Cyanide pit cleanup in progress, laying out the liner.

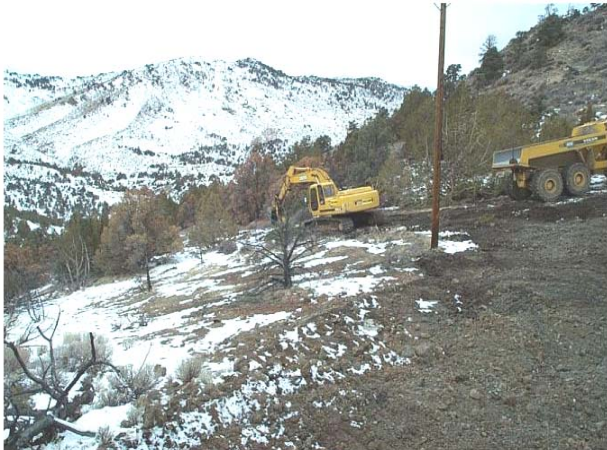
Cyanide pit cleanup in progress.

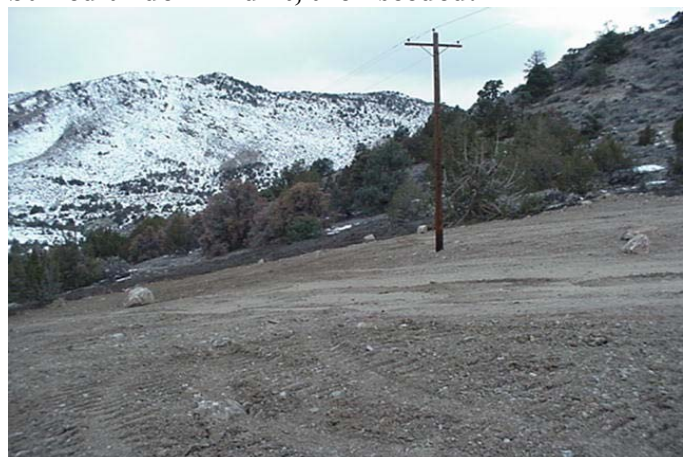
Cyanide pit cleanup is complete. Pit has been covered with a liner, which was buried under fill dirt, then seeded.
